# Shoulder Harnesses-Aircraft Restraint Systems, Survivable Accidents, & Recommendations

# Shoulder Harness Installation

**SHOULDER HARNESS ATTACH BRACKET**

FOR: J-3 thru PA-18

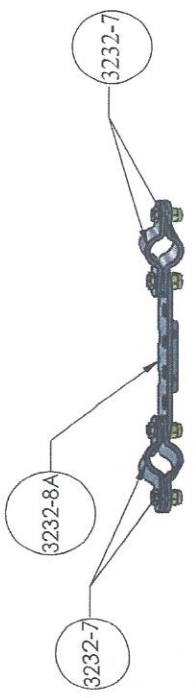
**3232-2**  
REAR SHOULDER HARNESS  
ATTACH BRACKET ASSEMBLY

### 2. Rear Shoulder Harness Attach Bracket Installation Instructions:

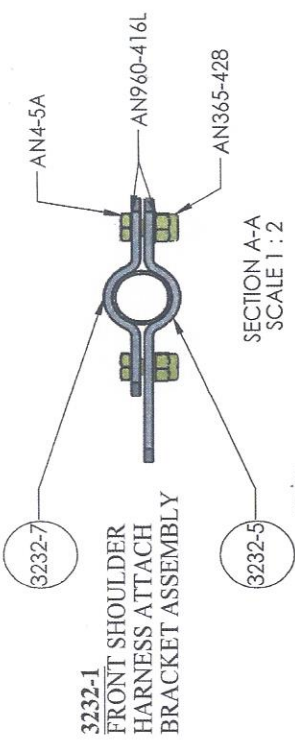
**3232-1**  
FRONT SHOULDER  
HARNESS ATTACH  
BRACKET ASSEMBLY

### 1. Front Shoulder Harness Attach Bracket Installation Instructions:

1. Refer to F. Atlee Dodge drawing 3232.
2. If a cloth headliner is installed, locate tube 10562-80. This tube is a 7/8" tube located just below the AFT edge of the skylight as fuselage station 33 7/8".

3. Find the center of this tube. A post is welded to the upper side of the tube so you must install the forward shoulder harness attach bracket to one side of this post. You may to remove a small amount of fabric headliner to be able to install the fitting.

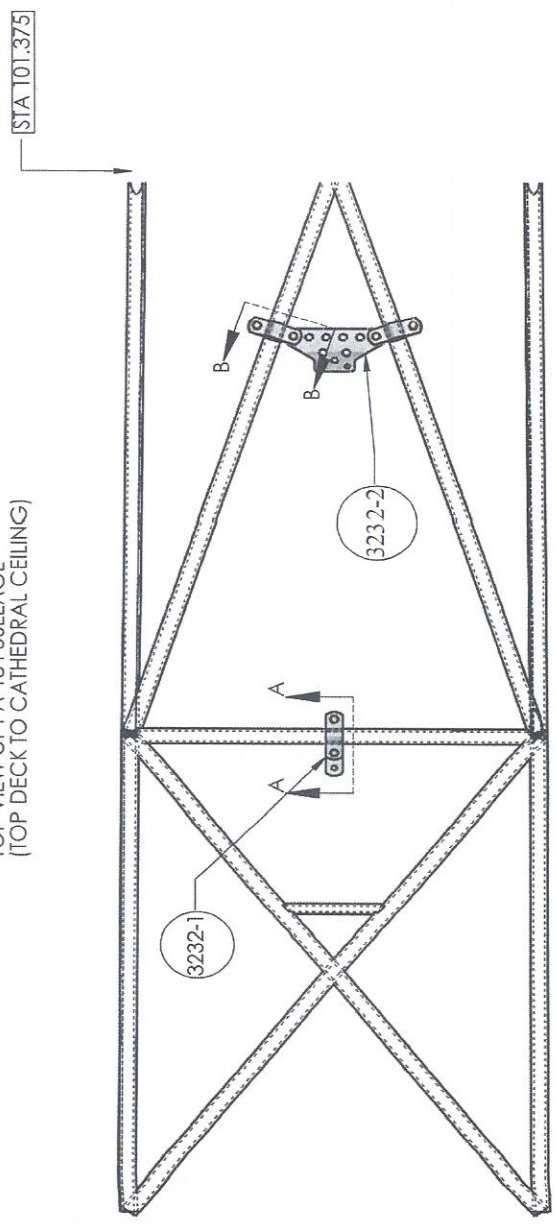
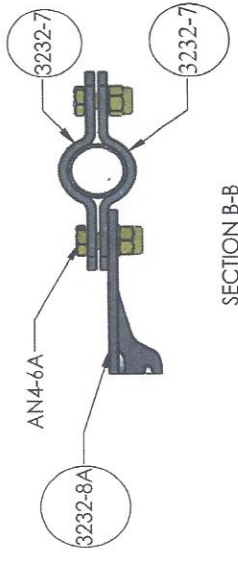
SECTION A-A  
SCALE 1 : 2

TOP VIEW OF PA-18 FUSELAGE  
(TOP DECK TO CATHEDRAL CEILING)

SECTION B-B  
SCALE 1 : 2
